Fault Recording in a UK Utility

David Cole
Peter Glover
Qualitrol Corporation

UK Case Study of the Deployment and Performance of a Large Scale Fault Monitoring System During Storm Conditions

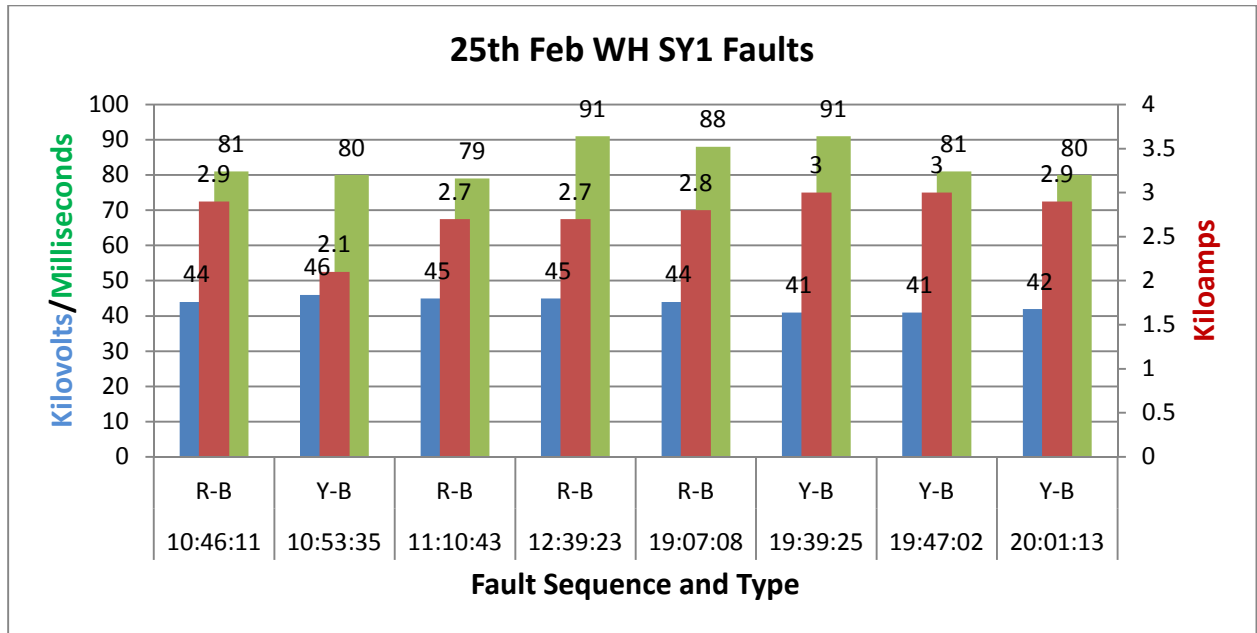
Fig 3 25th February Faults at Station WH on line SY1

Fault and triggered slow scan records from the relevant recorders were analysed to examine the fault activity in more detail. Fig 3 shows the minimum voltage, maximum fault current and clearance time for each of the 8 faults at WH substation on the SY1 circuit. As can be seen all were cleared successfully in 79 to 91ms with fault currents ranging from 2.1 to 3KA.

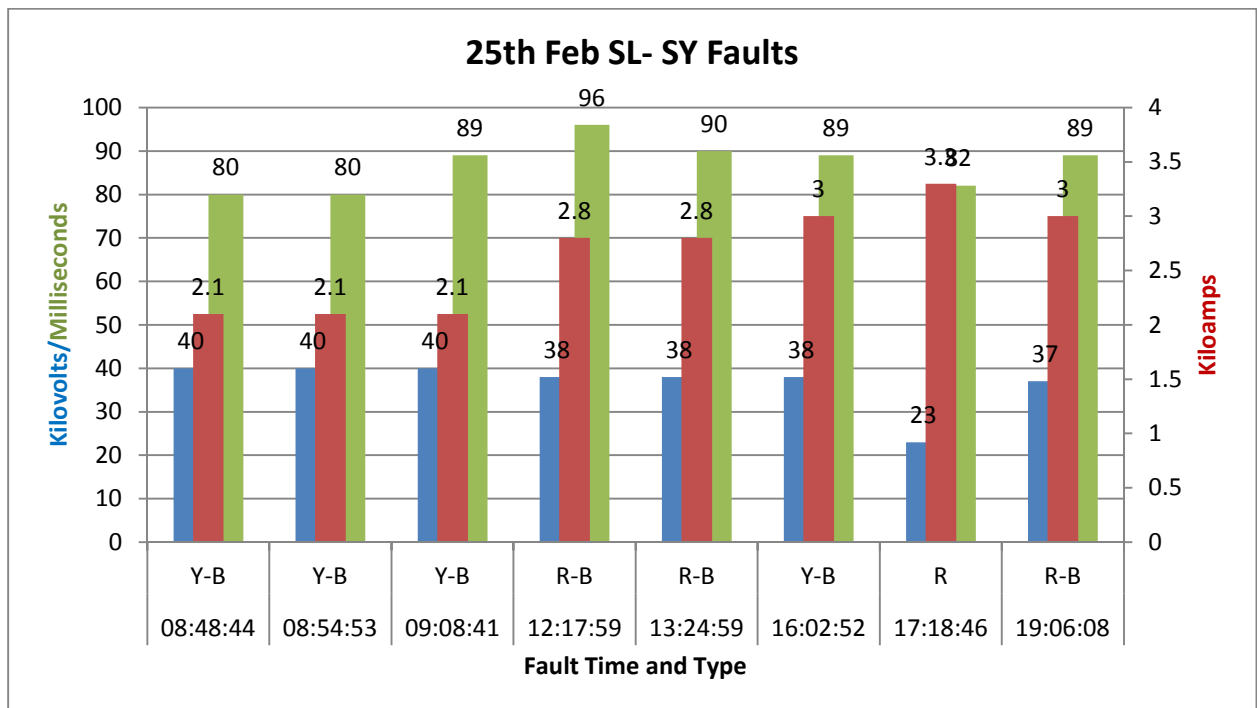
Fig 4 25th February Faults at Station SL on line SY

Fig 4 shows a similar situation for 8 of the 9 faults at substation SL on the SY circuit. However, the first fault of the day had a fault clearance time of 8 seconds indicating a sticking circuit breaker. Subsequent circuit breaker operations were successful. This will be analysed in more detail later.

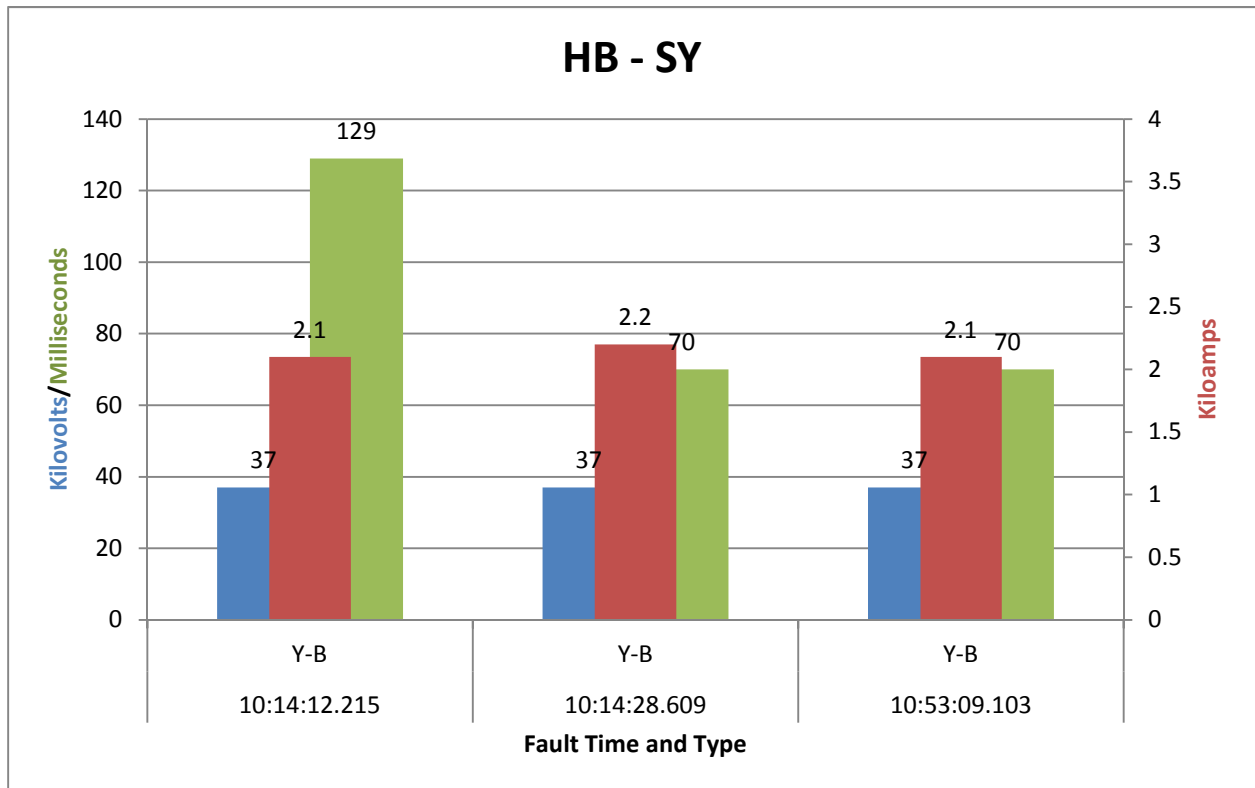
Fig 5 25th February Faults at Station HB on line SY

Fig 5 shows the results for the 3 faults at substation HB on the SY circuit. Note the relatively slow clearance time of 120ms for the first trip as opposed to 70ms for the next two. Fault current and minimum voltages were similar for all three faults indicating a slow first trip of the circuit breaker.

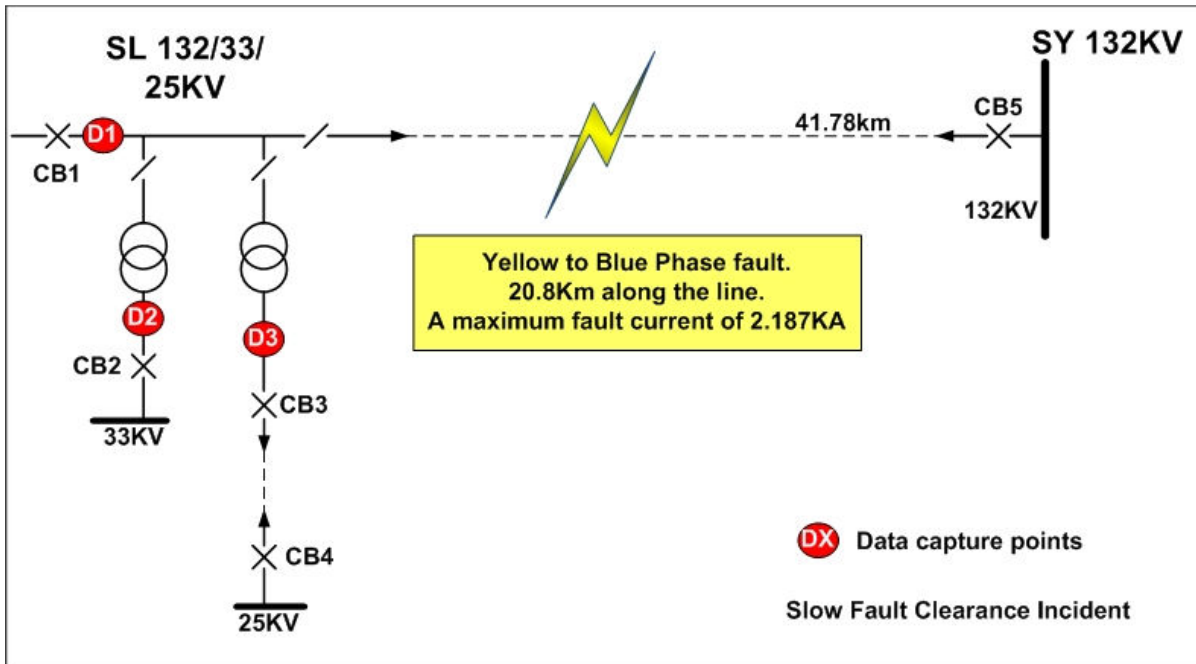
Fig 6 Basic network diagram of fault

The first fault of the day that occurred on the 25th on the SL to SY line was only partially cleared by the protection. The fault was a phase to phase fault caused by snow loading on the line and high winds. A more detailed single diagram of the network is shown in Fig 6.

CB1, CB5 and CB3 all operated within 120ms of fault inception, however CB2 remained closed and continued to back feed the fault until it self extinguished almost 3 seconds later. A further 5 seconds after this CB2 finally operated.

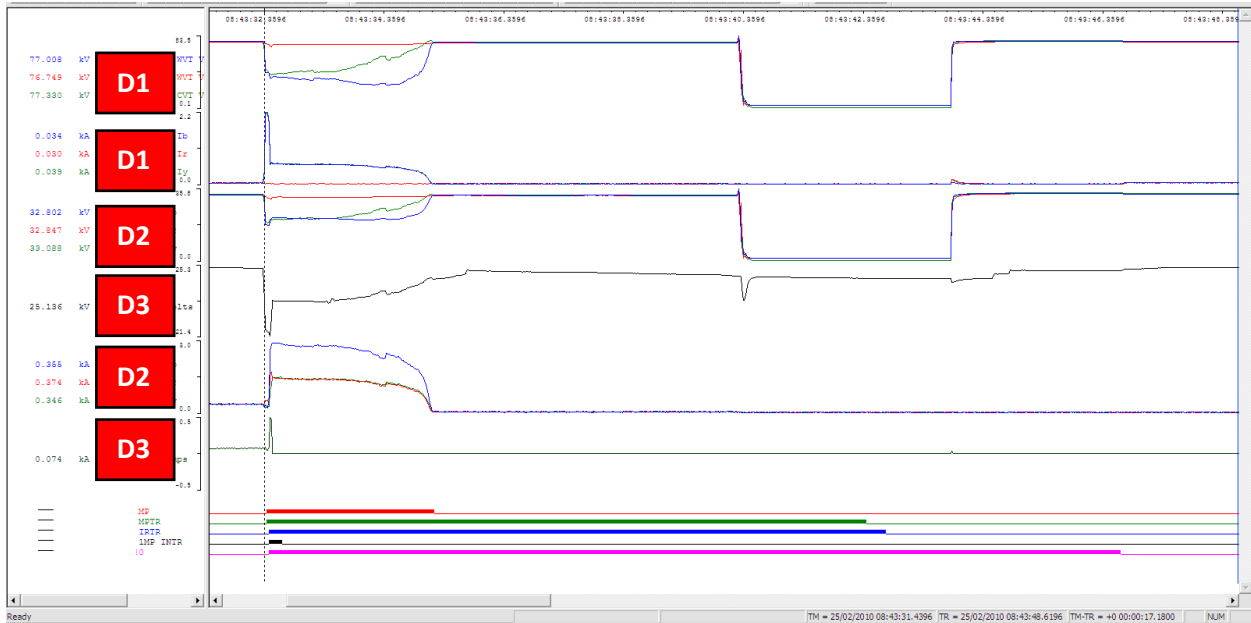
Fig 7 TSS Record showing full fault duration and Auto Reclosure

The triggered slow scan record from SL (Fig 7) shows the full duration of the event from fault inception to the successful auto-reclose approximately 12 seconds later. Note that the phase current measured at D1 is the summation of the line current and the 2 HV transformer currents. Only single phase quantities are available from D3. The record shows fast clearance of the main fault current by operation of breakers CB1, CB5 and CB3. However reduced fault current continued to be fed into the fault from the closed D2 circuit breaker. The current reduced to zero after 3 seconds when the phases parted and the arc extinguished but CB2 did not open until another 5 seconds had elapsed collapsing the volts measured at D1. CB5 auto reclosed after 12 seconds and CB1 after approximately 15 seconds.

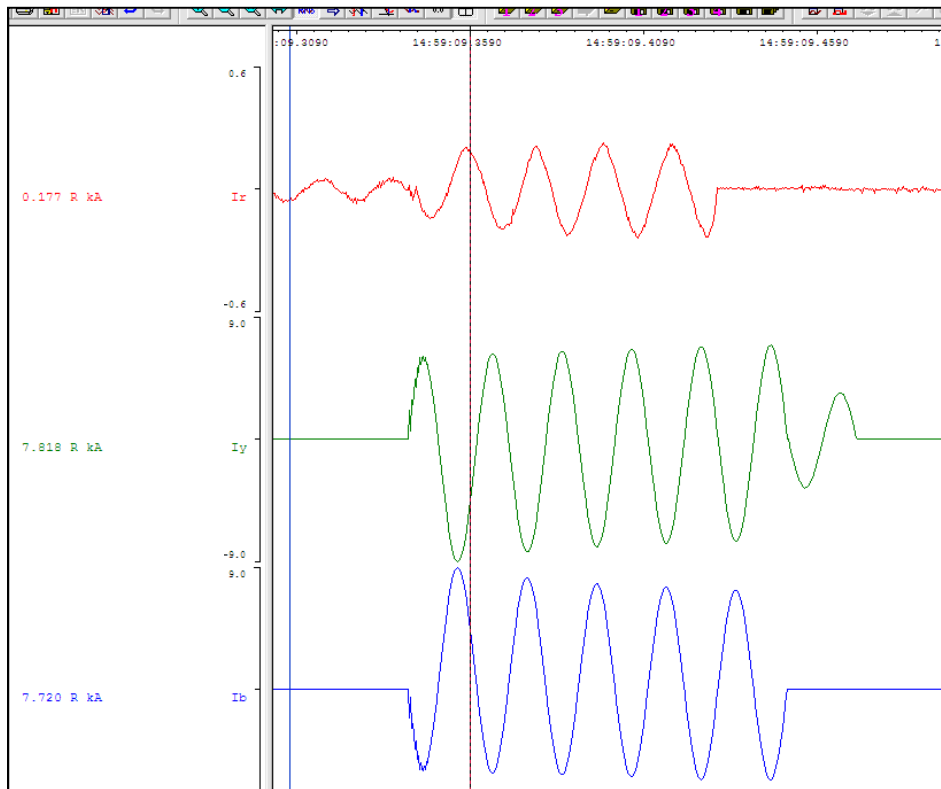
Fig 9 Circuit Breaker clearing fault current showing pole stagger

Detailed examination of the first fault at 14.59 revealed excessive pole spread when the circuit breaker operated. Note that the red phase trace has been magnified and is on a different scale to other phases.

It can be seen that each of the current reduces to zero at a different time. The red phase is the first to be extinguished, then the blue phase 20.16ms later and finally the yellow phase a further 20ms later. This resulted in a large spike in residual current which lasted for a cycle. See Fig 10.

Note that the same effect was not seen in subsequent operations suggesting that it was caused by a sticking mechanism cleared after the first operation. It does suggest maintenance is required.

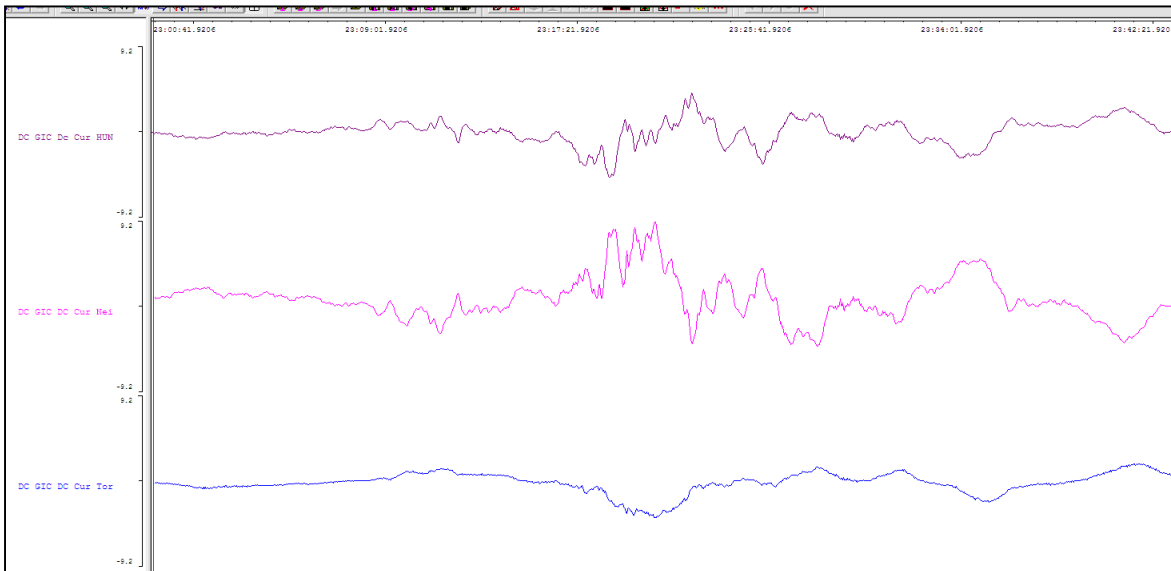
Fig12 GIC Data

Fig 12 below shows some recorded data from the one of the Utility’s GIC monitors. During this storm there were burst of GICs that lasted for minutes peaking at 13Amps. During sustained storms the Utility takes steps to reduce transformer load to avoid overheating.

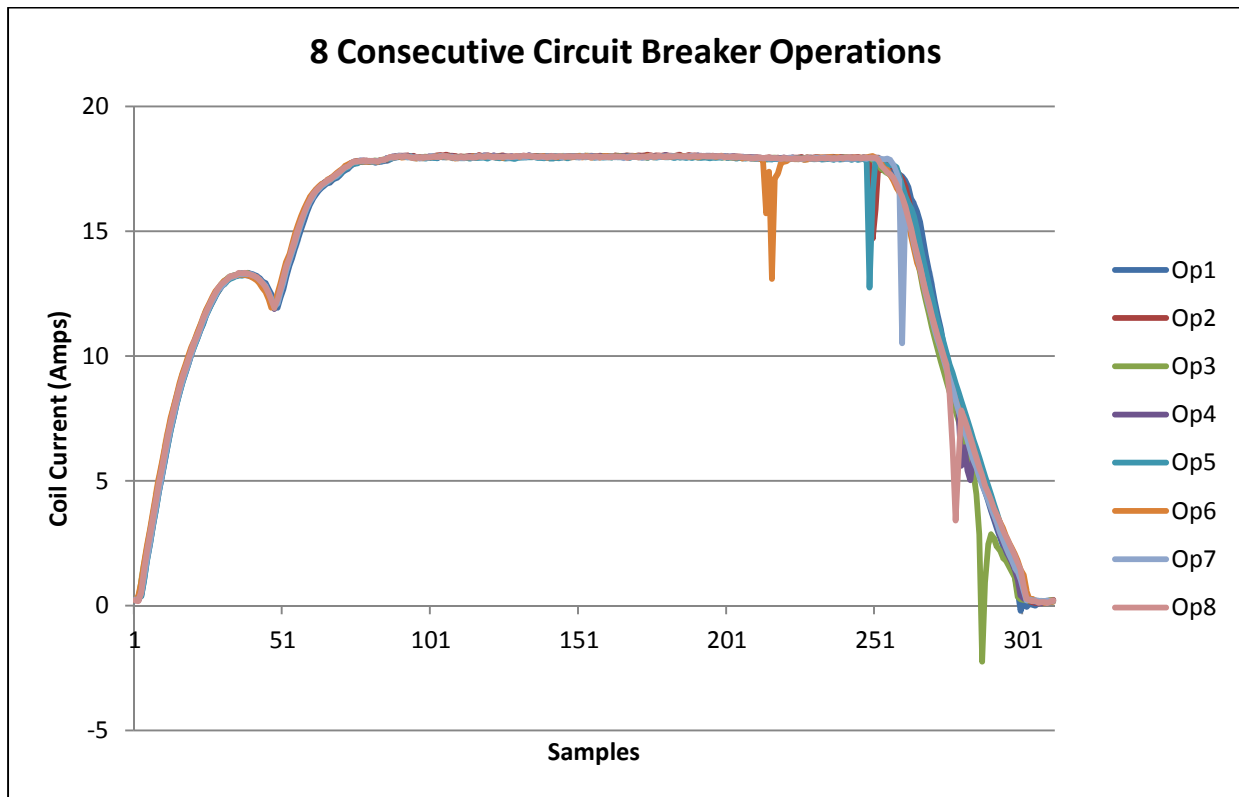
Fig 15 Circuit Breaker trip coils from 8 operations

Eight profiles from consecutive circuit breaker operations from the 25th of February at substation WH for the SY1 line show no significant differences apart from some spikes on the current decay that could be caused by arcing on an auxiliary contact. Changes in the latch mechanism or breaker operate time would result in a different shape.

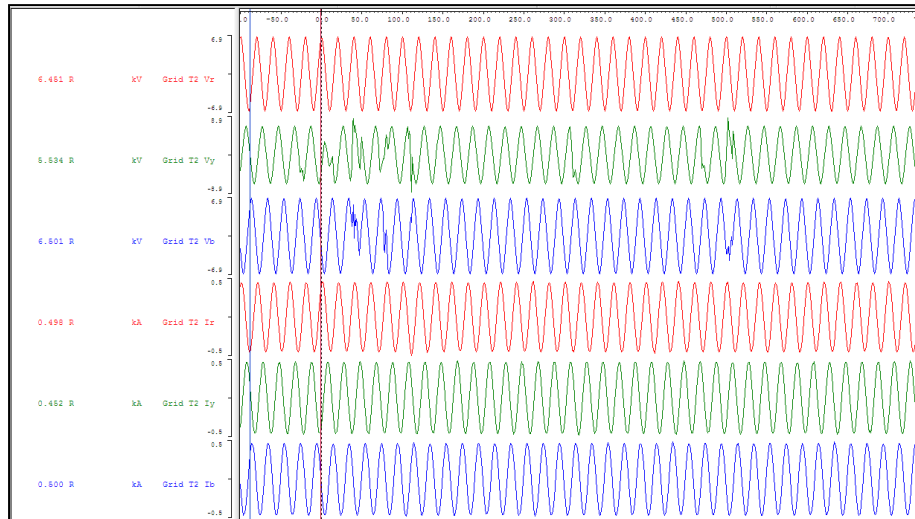
Fig 16 CVT Issues Captured by the Recorders

Another phenomena recorded by the Fault Monitoring System during the February storm were several CVT perturbations as seen in the voltage traces in Fig 16.

The recorder triggers on under voltage otherwise the Utility would not know this was happening. It would certainly not be detected by a relay. The cause is transient operation of the over voltage protection circuit on the secondary of the CVT. It has been detected on many different types of devices and if it gets too repetitive or severe then a line outage is organised and CVT maintenance undertaken. If left it could result in the loss of one or more phase voltages that would drastically affect protection performance.
