Fault Recording in a UK Utility

David Cole
Peter Glover
Qualitrol Corporation

UK Case Study of the Deployment and Performance of a Large Scale Fault Monitoring System During Storm Conditions

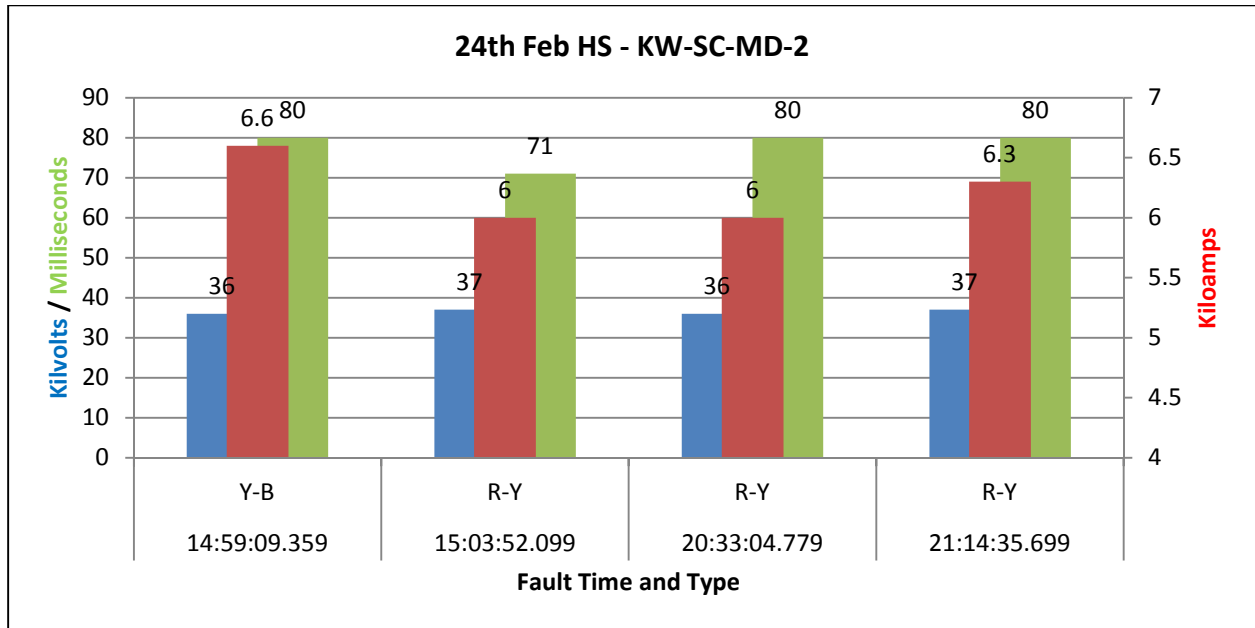
Fig 9 24th February Faults at Station HS on line KW-SC-MD-2

Detailed examination of the first fault at 14.59 revealed excessive pole spread when the circuit breaker operated. Note that the red phase trace has been magnified and is on a different scale to other phases.

It can be seen that each of the current reduces to zero at a different time. The red phase is the first to be extinguished, then the blue phase 20.16ms later and finally the yellow phase a further 20ms later. This resulted in a large spike in residual current which lasted for a cycle. See Fig 10.

Note that the same effect was not seen in subsequent operations suggesting that it was caused by a sticking mechanism cleared after the first operation. It does suggest maintenance is required.

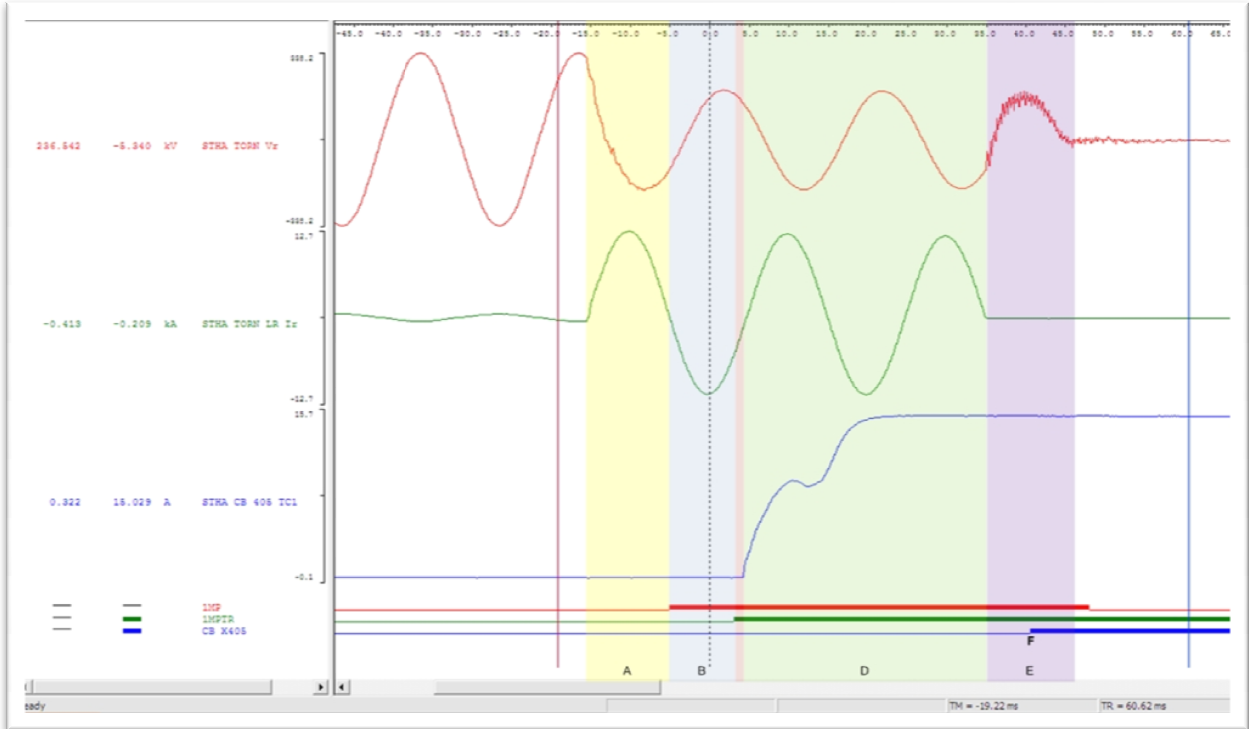
Fig 13 Fault with Trip Coil Current Profile

Eight profiles from consecutive circuit breaker operations from the 25th of February at substation WH for the SY1 line show no significant differences apart from some spikes on the current decay that could be caused by arcing on an auxiliary contact. Changes in the latch mechanism or breaker operate time would result in a different shape.
